PENNSYLVANIA
ID NO. PA. 00789

IRONWORKS DAM

PHASE I INSPECTION REPORT NATIONAL DAM INSPECTION PROGRAM

June 1978

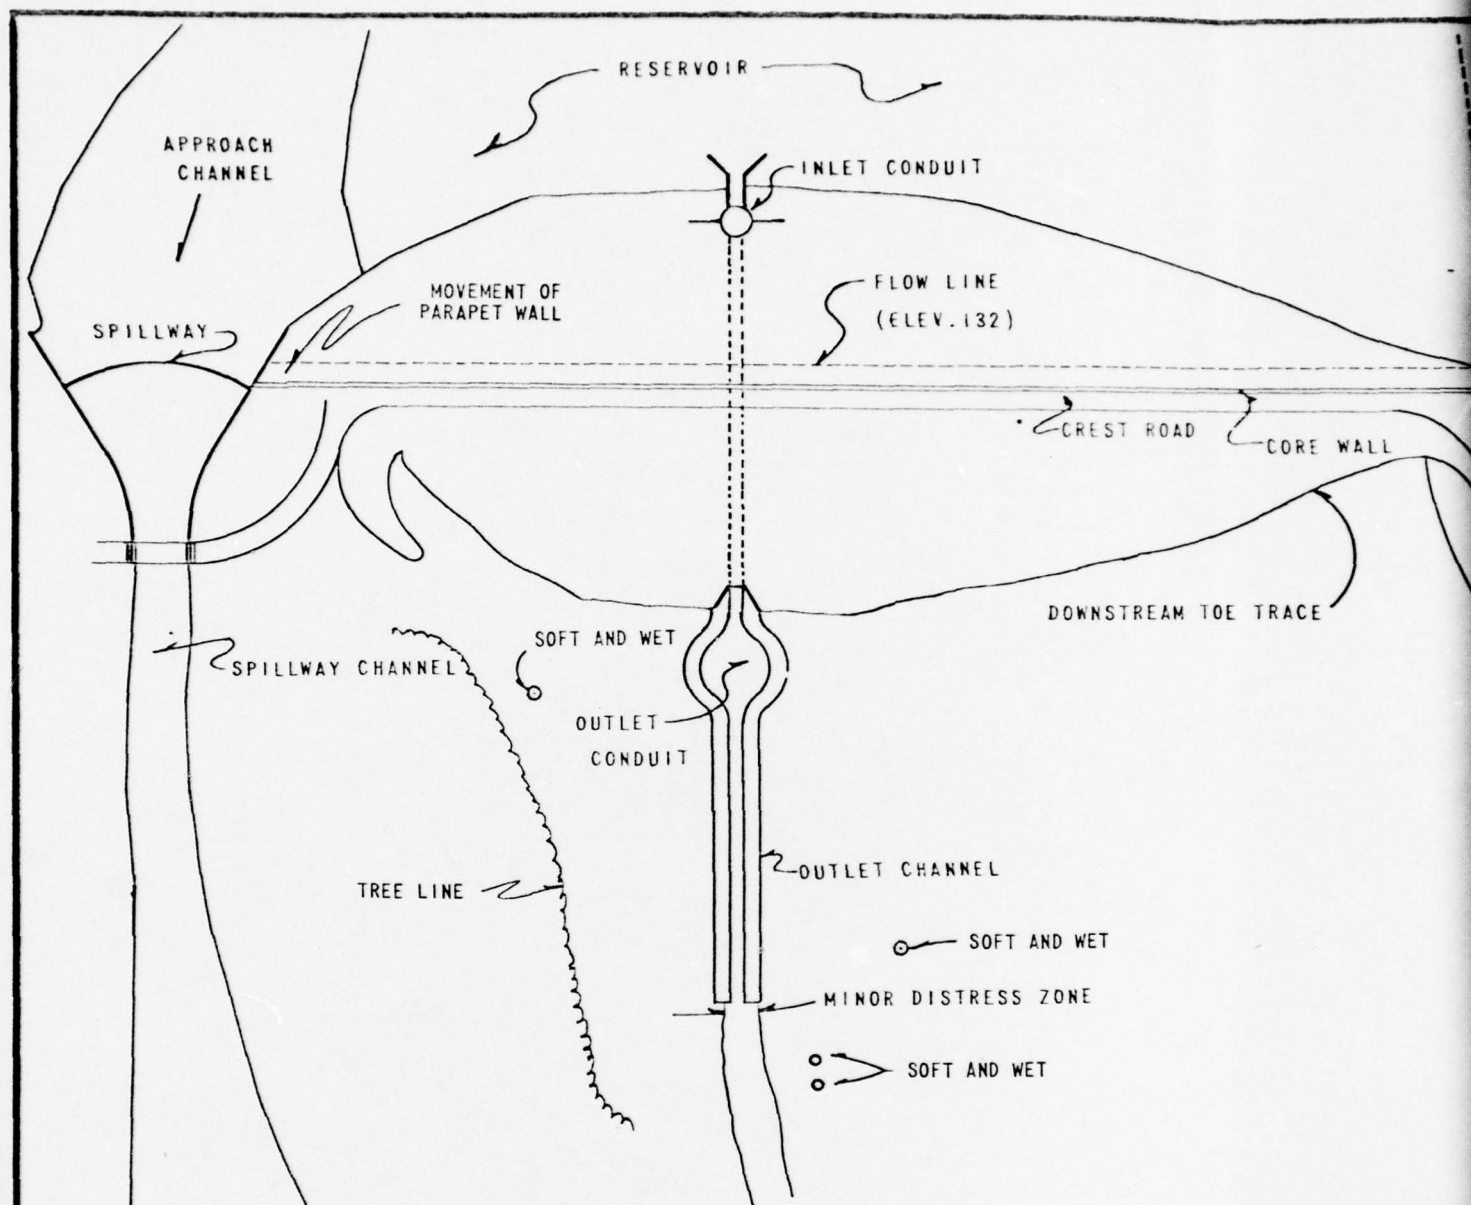
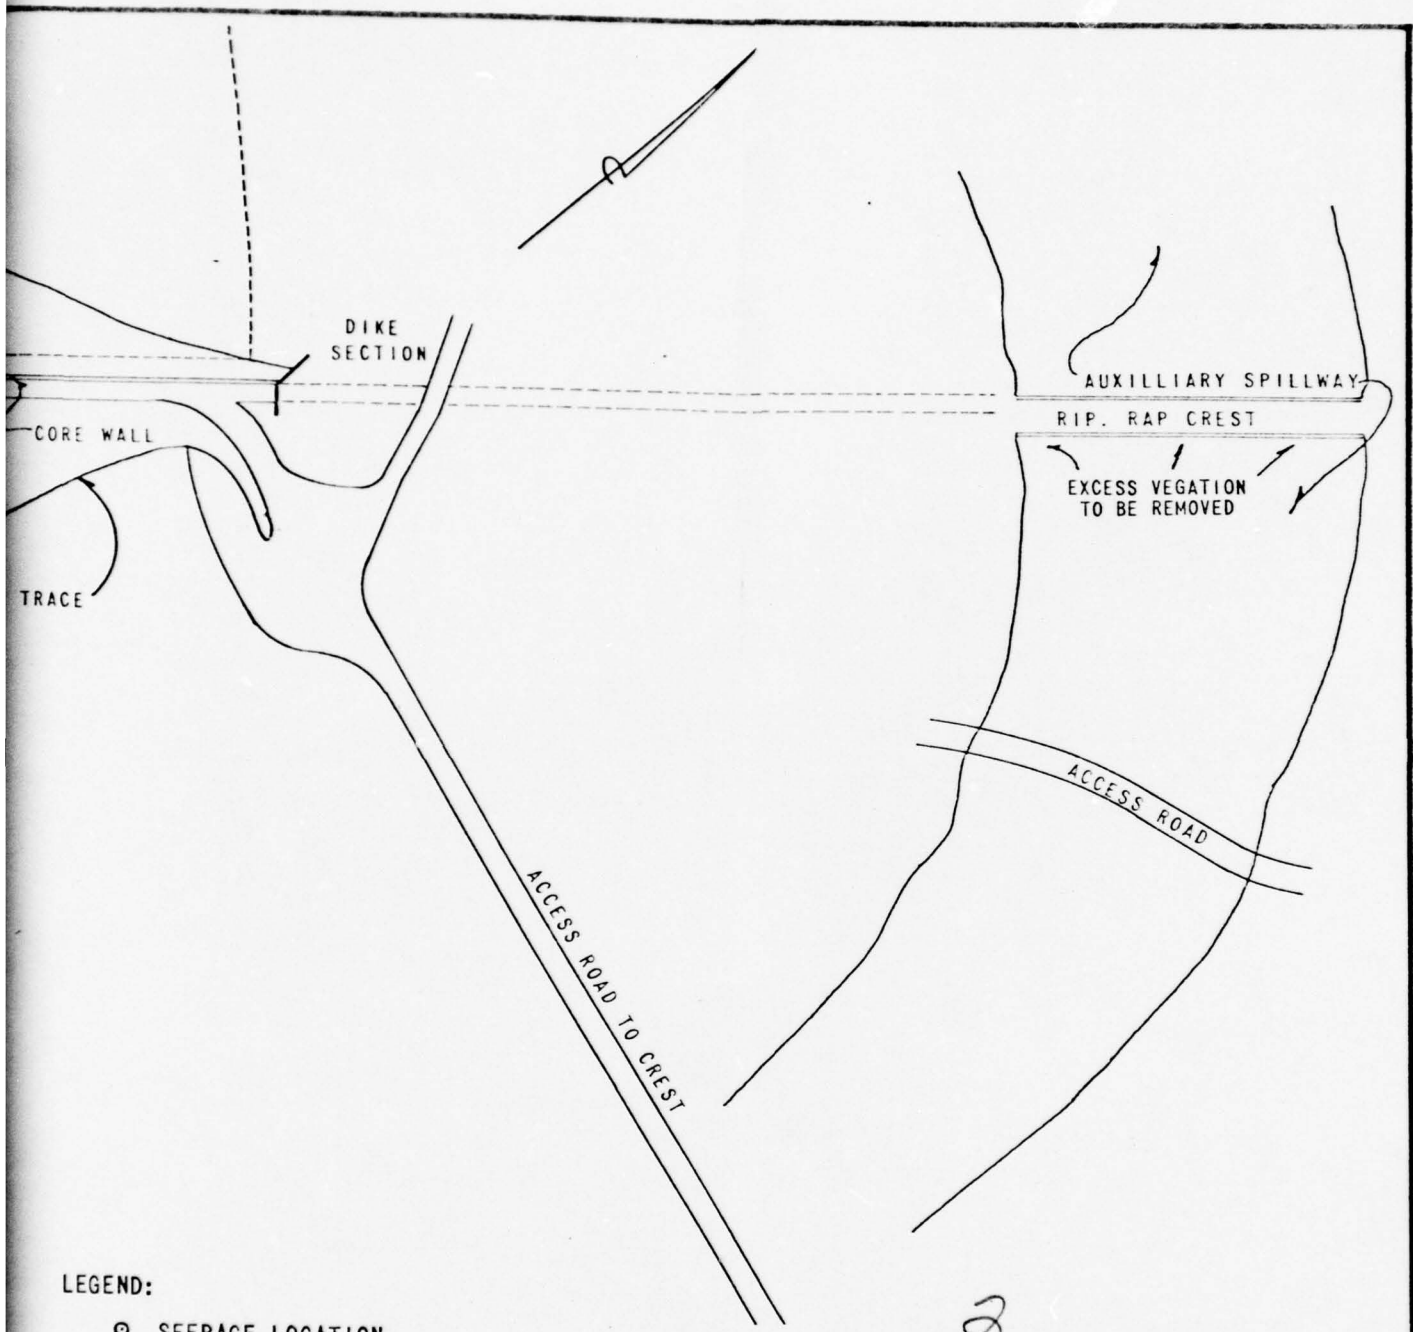
VISUAL EXAMINATION OF	OBSERVATIONS	REMARKS OR RECOMMENDATIONS
JUNCTION OF EMBANKMENT AND ABUTMENT, SPILLWAY AND DAM	Nothing unusual observed.	
ANY NOTICEABLE SEEPAGE	None on the embankment but seepage was observed beyond the downstream toe on both sides of the outlet discharge channel. These seeps are located as shown on sheet 5a. Water was not flowing from the seeps but the areas were soft and wet.	
STAFF GAGE AND RECORDER	None.	
DRAINS	None observed.
